Debris/Ice/TPS Assessment and Integrated Photographic Analysis of Shuttle Mission STS-70

Gregory N. Katnik, Barry C. Bowen, J. Bradley Davis

13 July 1995

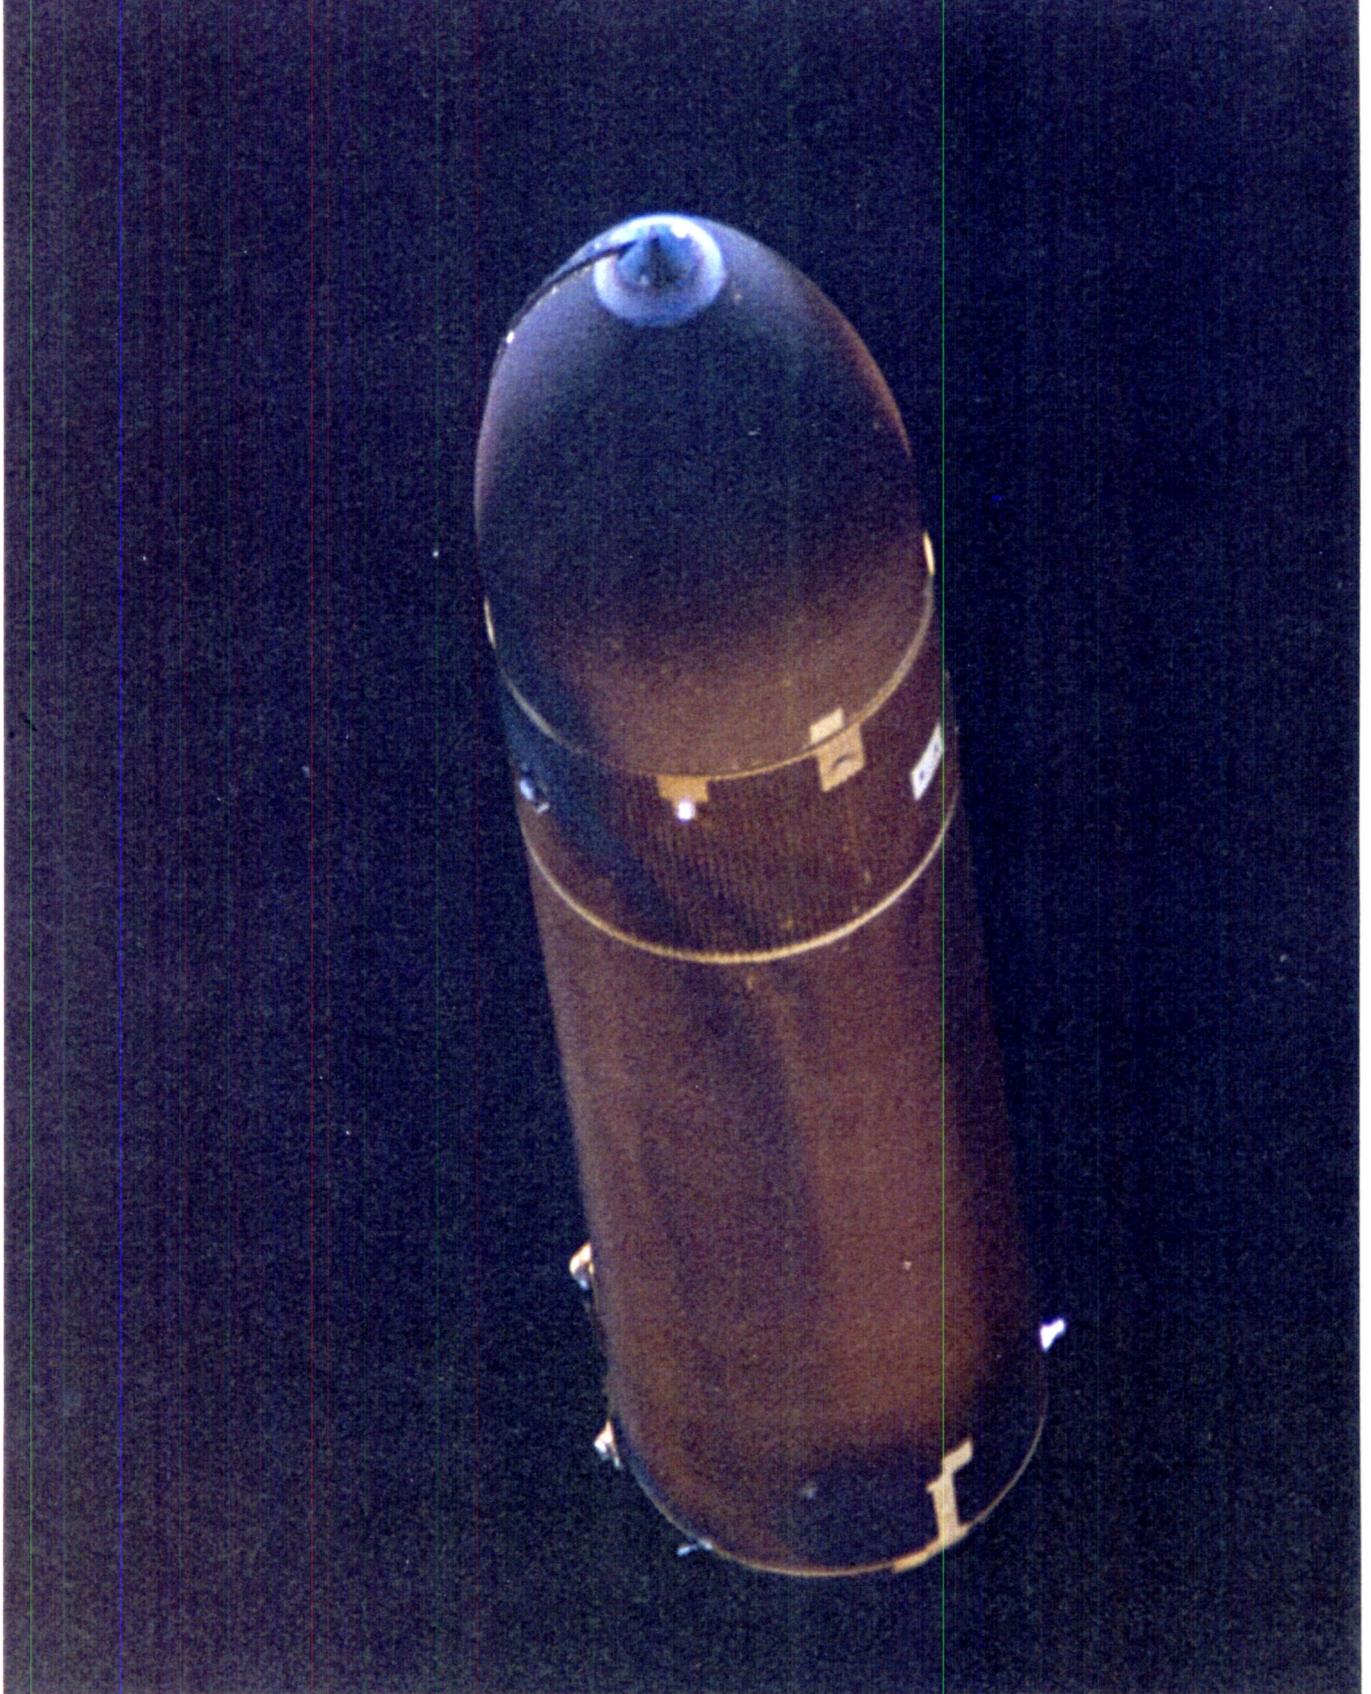
Photo 13 : ET After Separation from Orbiter

No divots or TPS anomalies were observed at the locations of the woodpecker damage site repairs. Light-colored areas on the -Z side of the intertank were previous repairs and sanded areas, rather than new divots, documented prior to flight.

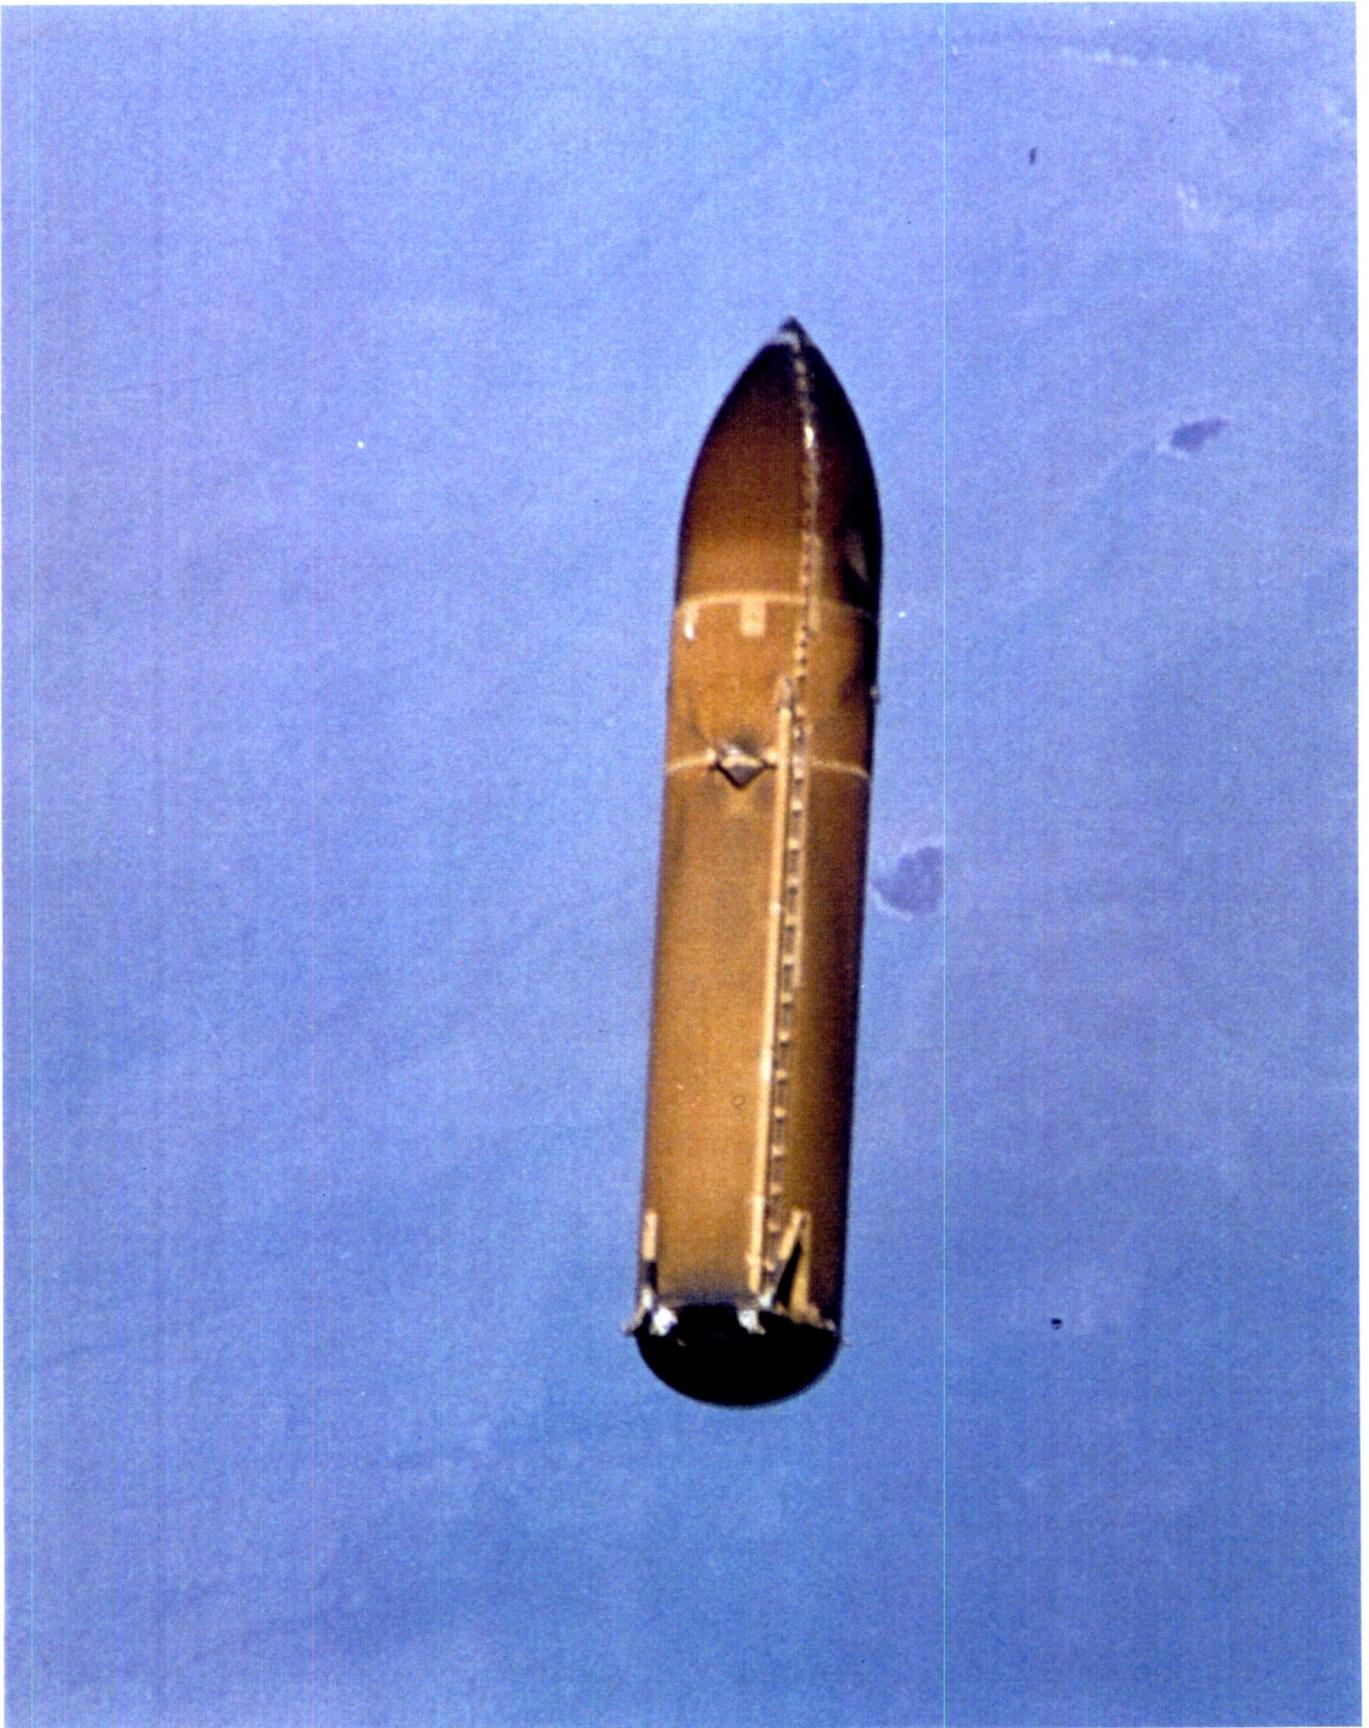
Photo 14 : External Tank +Z Side

Unusual comprehensive photographic coverage of the ET +Z side showed no intertank acreage or stringer head divots and no intertank-to-LH2 tank flange closeout divots. Both redesigned bipod jack pad closeouts were intact and appeared to be in good condition.

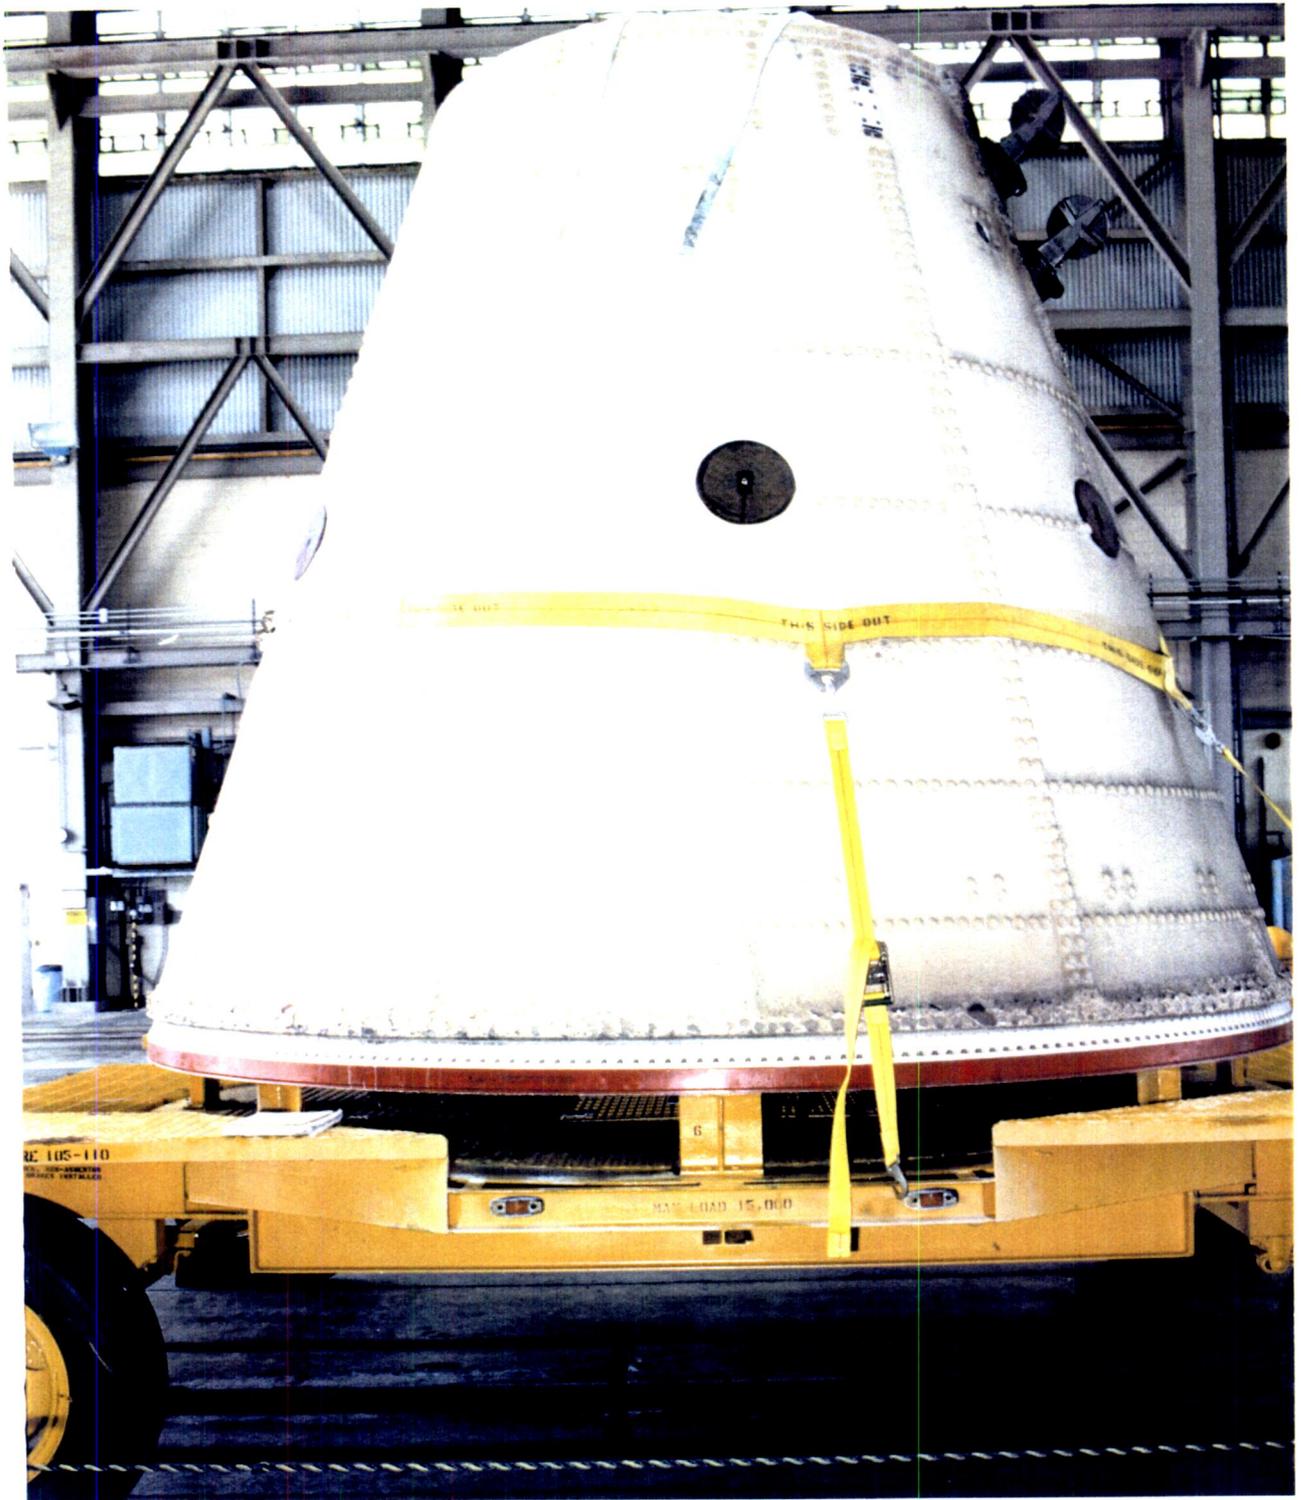
Photo 15 : RH SRB Frustum

The RH frustum was missing no TPS. The number of debonds (29) over fasteners was average. Hypalon paint was blistered/missing where BTA closeouts had been applied. The BSM aero heat shield covers had locked in the fully opened position though the left two cover attach rings had been bent by parachute riser entanglement.

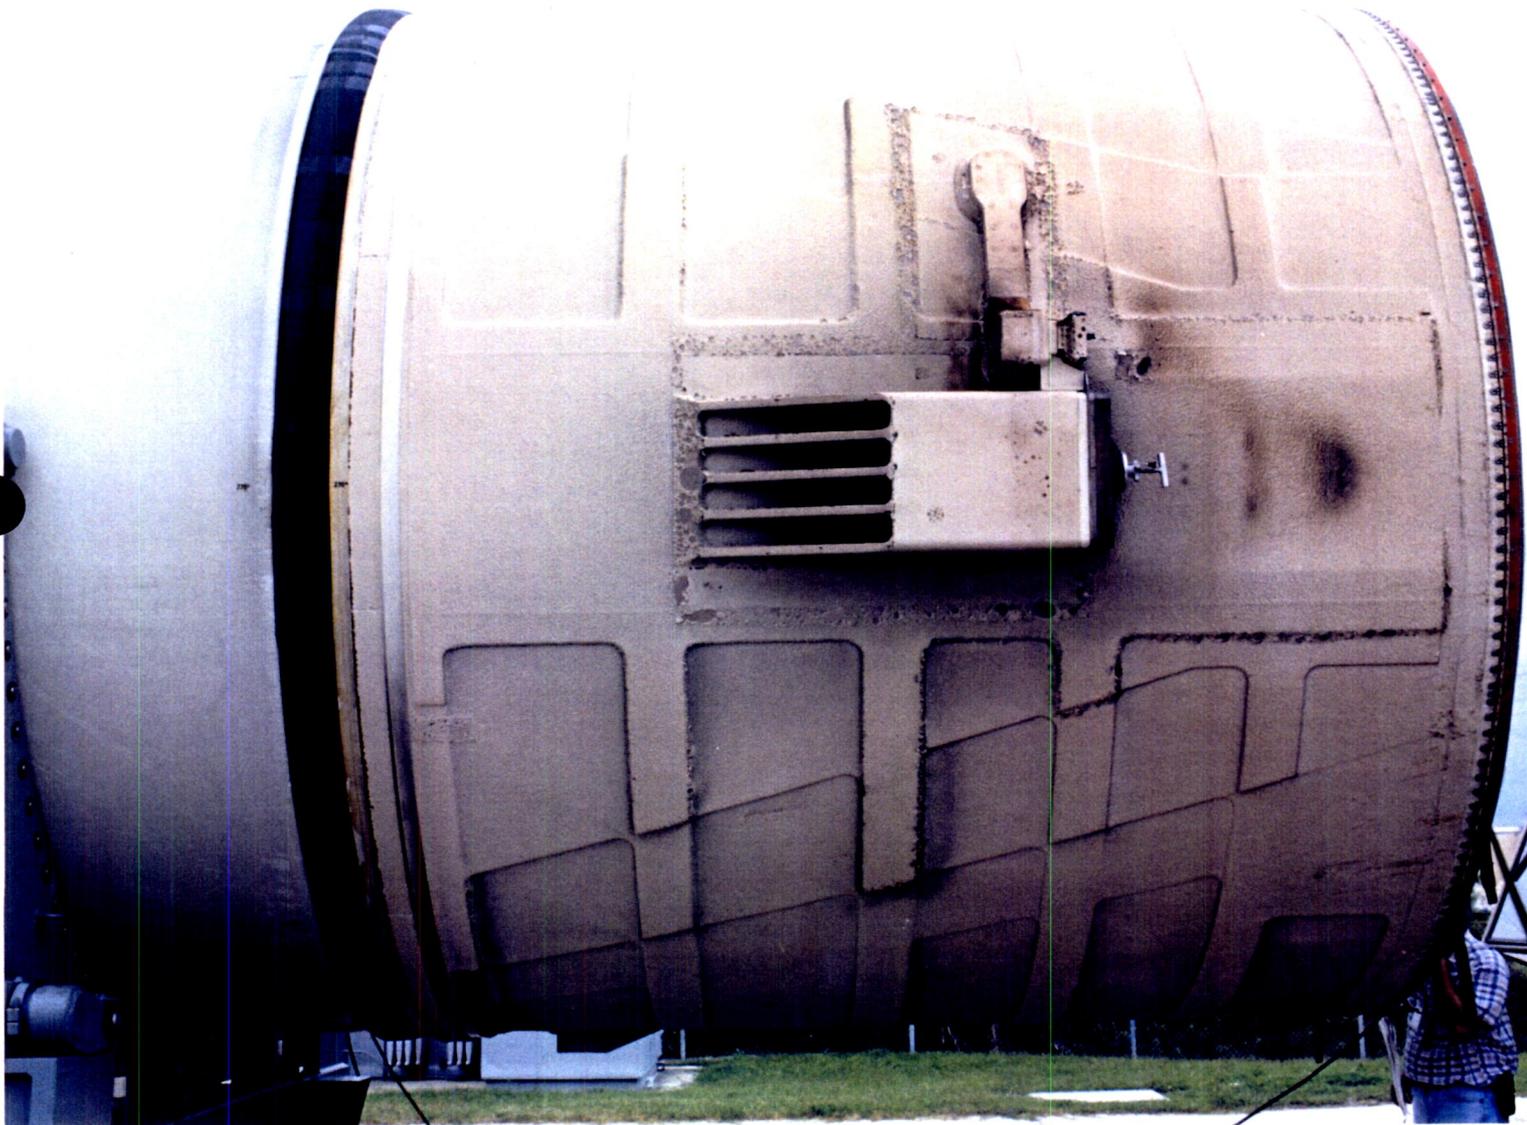
Photo 16 : RH Forward Skirt

The RH forward skirt exhibited no debonds or missing TPS. Hypalon paint was blistered/missing over the areas where the BTA closcouts had been applied.

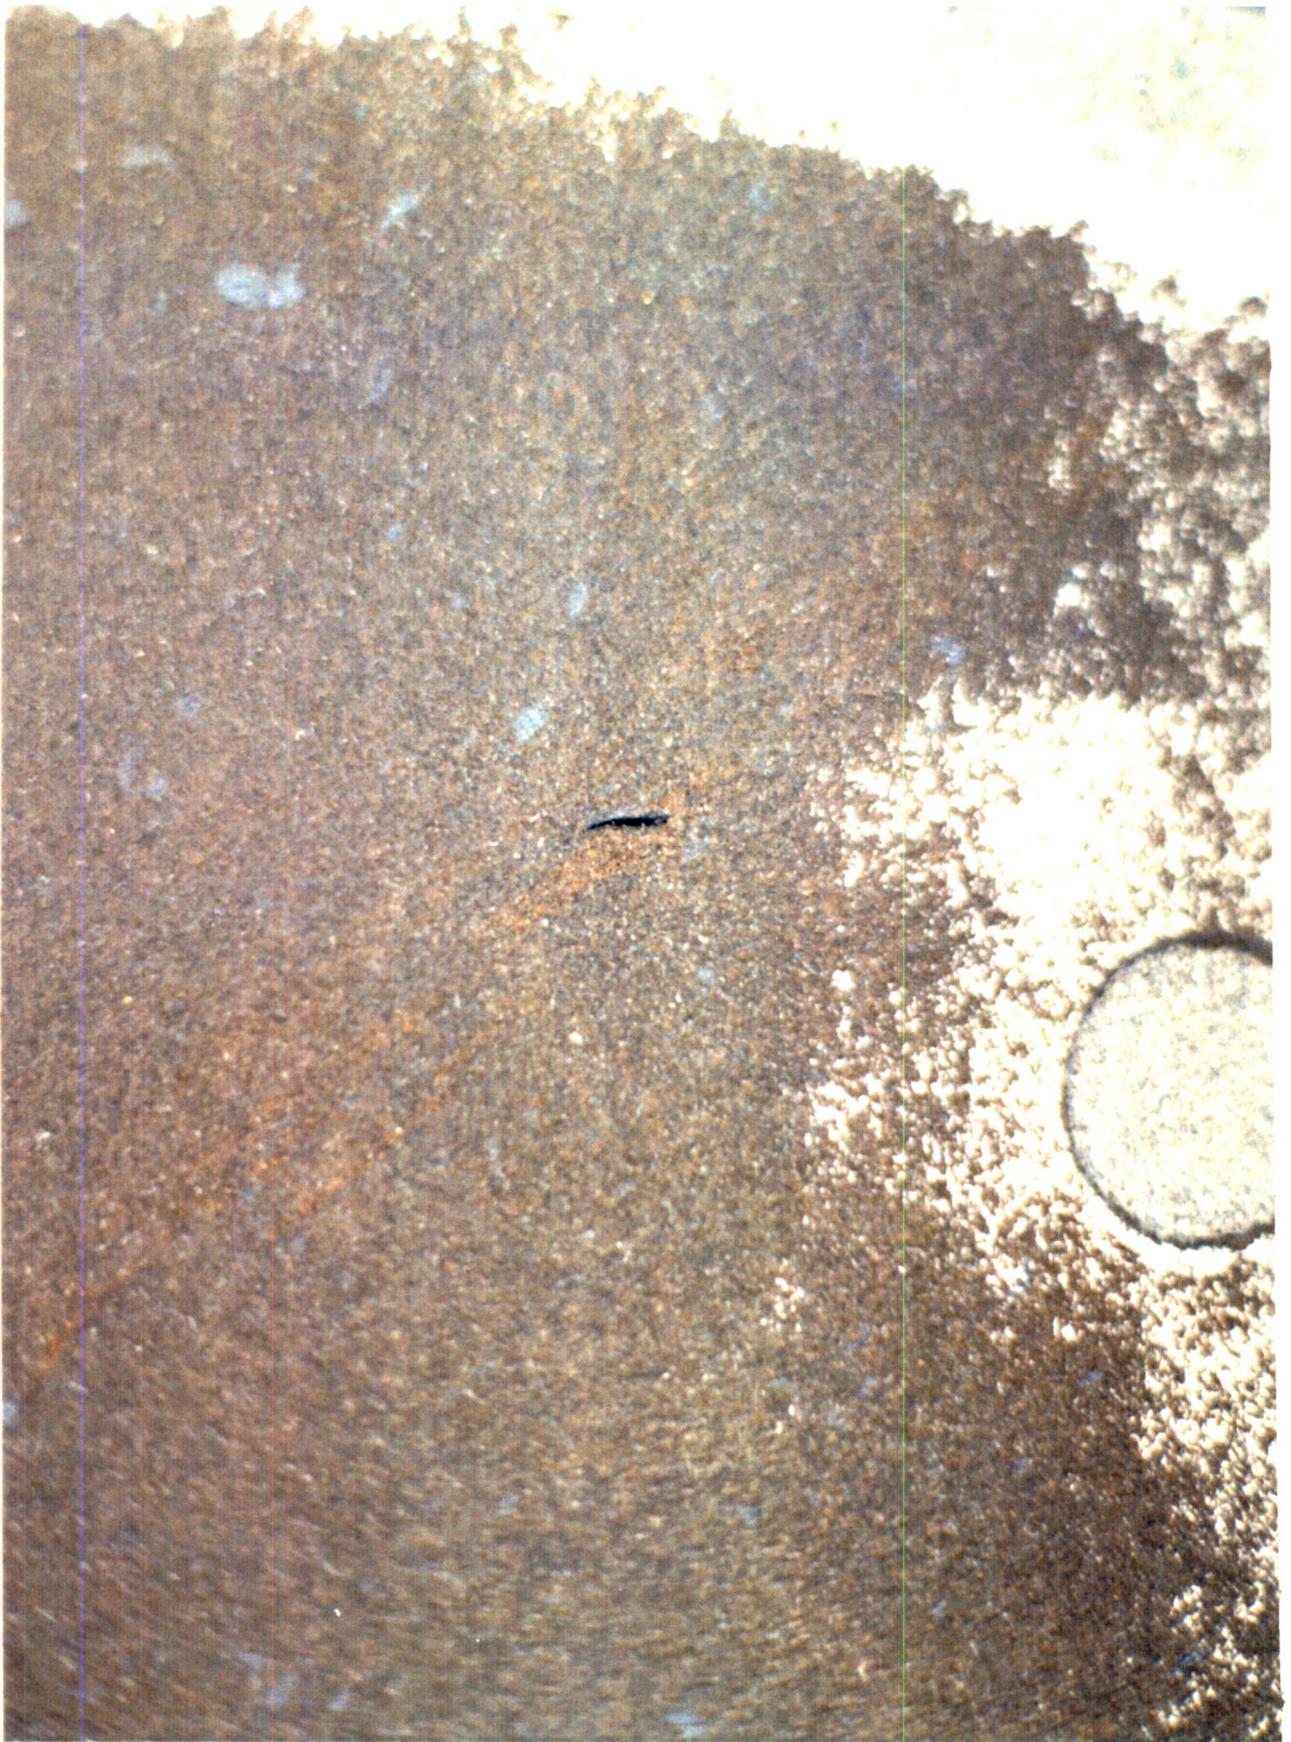
Photo 18 : Gouge on RH Aft BSM Fairing

Aft skirt hypalon paint was blistered over areas where BTA closeouts had been applied. A 0.4 inch long by 0.1 inch wide by 0.15 inch deep gouge on the forward-facing surface of the aft outboard BSM fairing (closest to the +Z axis) was analyzed by the MSFC materials laboratory, which determined the gouge was most likely caused by SRM insulation NBR rubber (reference PR PV6290235 and USBI Report BLV-050-95MP). The BSM aft attach bracket adjacent to HDP #1 was missing K5NA to substrate. The HDP Debris Containment System (DCS) plungers were seated and appeared to have functioned properly.

A 0.4 inch long by 0.1 inch wide by 0.15 inch deep gouge on the forward-facing surface of the aft outboard BSM fairing (closest to the +Z axis) was most likely caused by SRM insulation NBR rubber

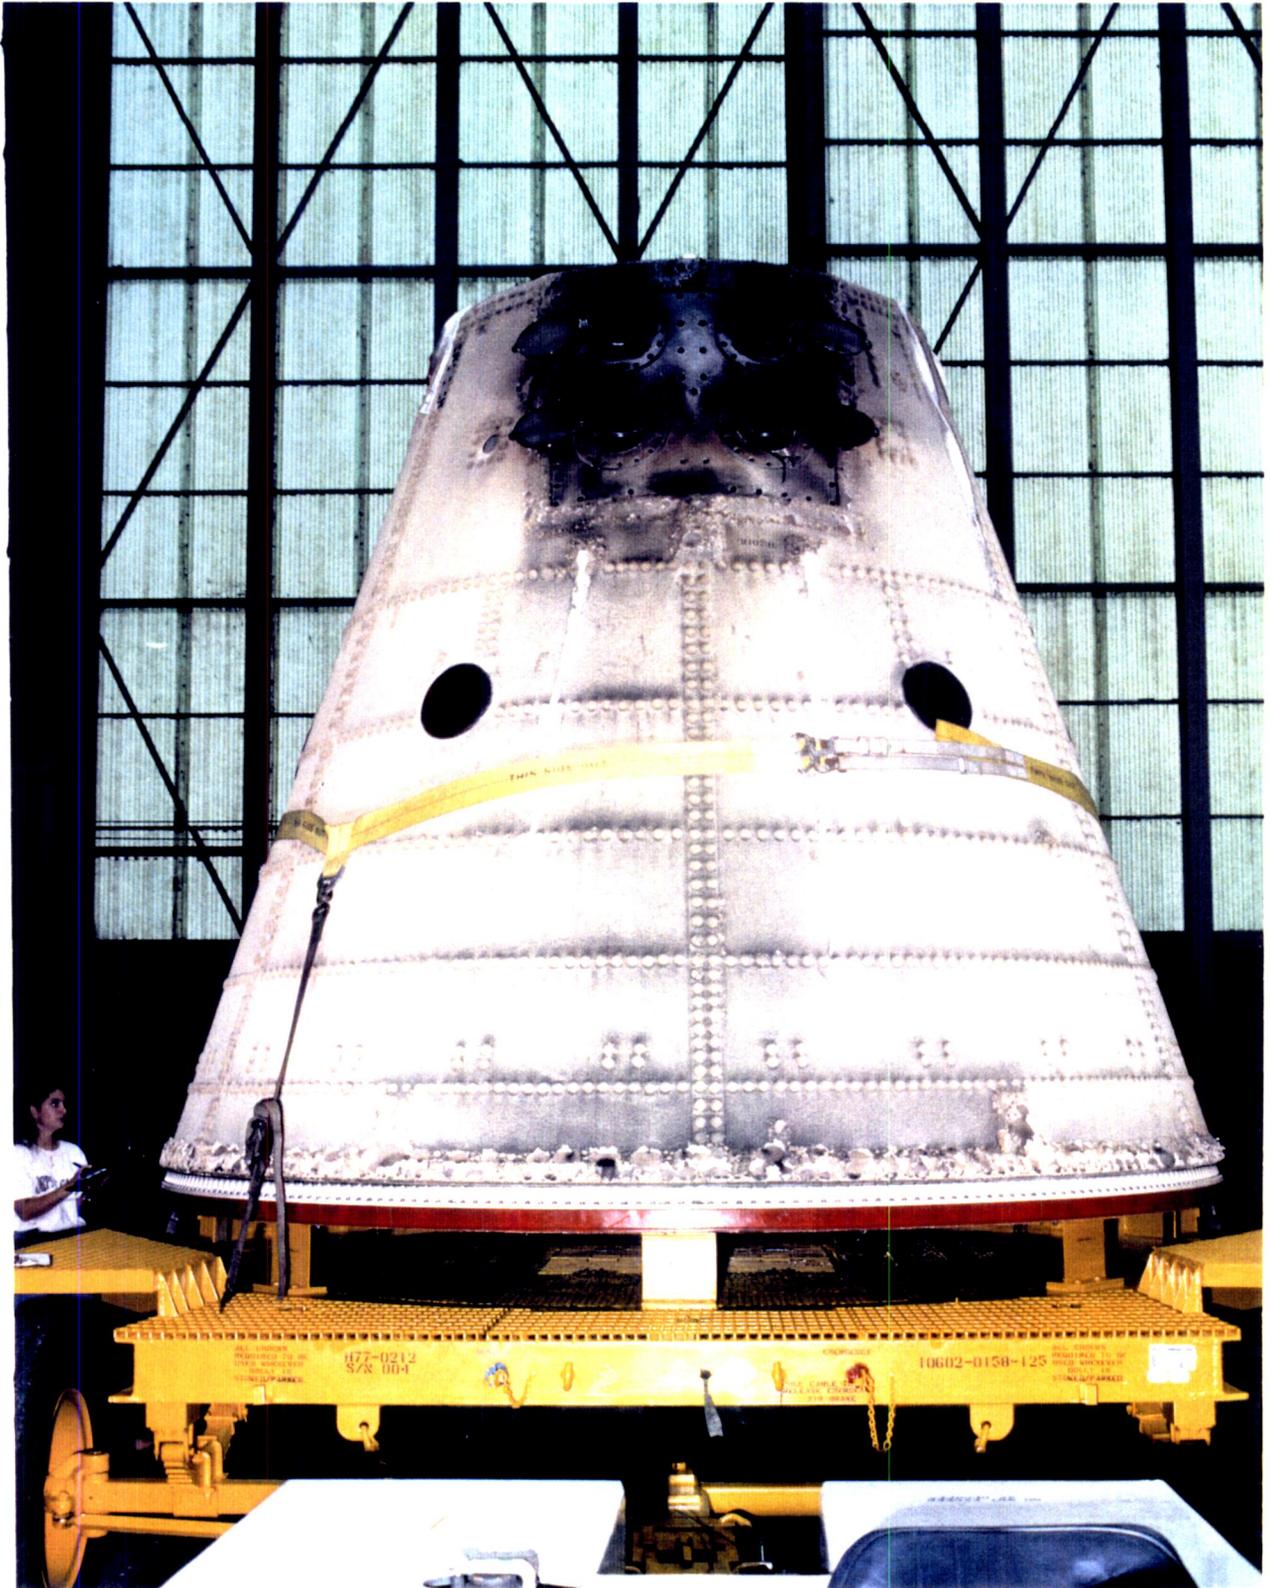
Photo 19 : LH SRB Frustum

The LH frustum was missing no TPS. The number of MSA-2 debonds (28) over fasteners was average. Hypalon paint was blistered/missing along the XB-395 ring frame where BTA closeouts had been applied. The BSM aero heat shield covers had locked in the fully opened position.

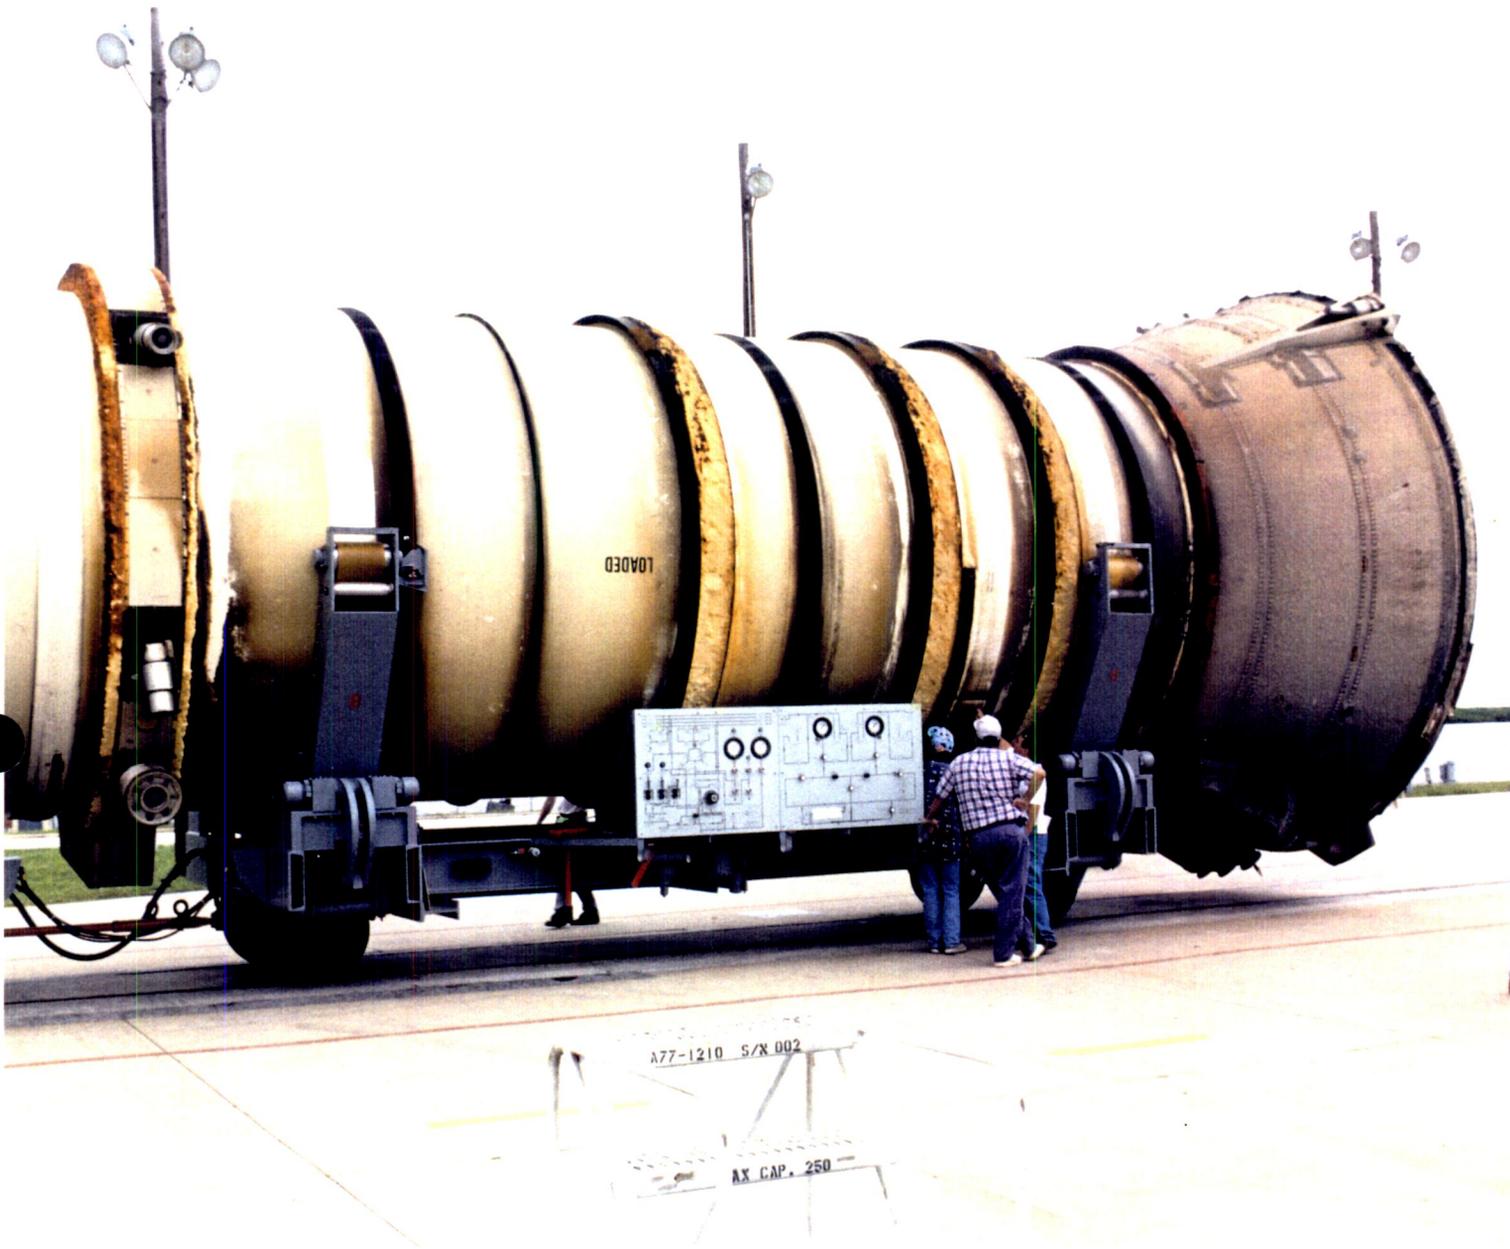
Photo 21 : LH Aft Booster/ Aft Skirt

Two 5"x2" MSA-2 divots were present over aft skirt fastener heads. The divots appeared to expose lightly-sooted substrate. Hypalon paint was blistered/missing over the areas where BTA closeouts had been applied. The HDP Debris Containment System (DCS) plungers were seated and appeared to have functioned properly with the exception of HDP #7. The plunger had been obstructed by a frangible nut half most likely as the result of water impact.

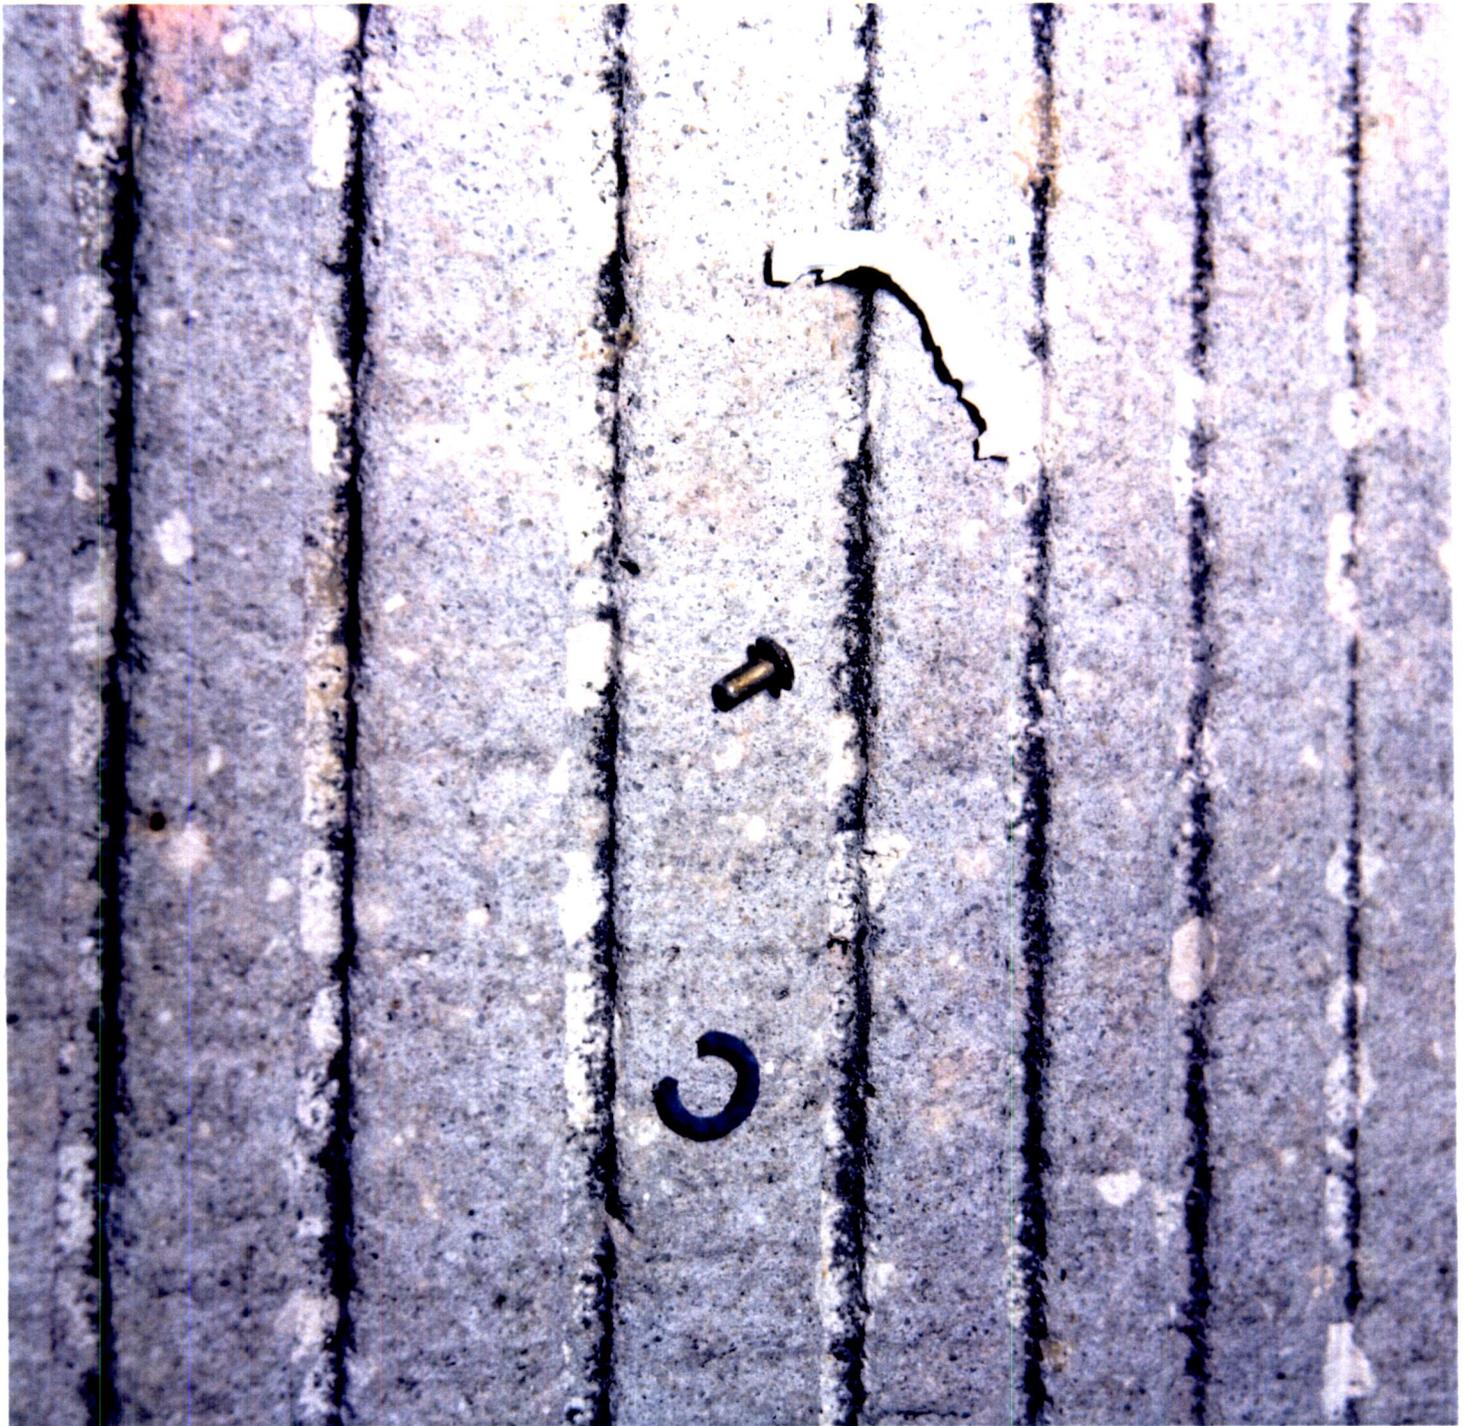
Photo 26 : Debris on Runway

Hardware found on the runway included a 1-inch long piece of white RTV below the LH2 ET door, part of a metallic rivet beneath the EO-2 area, and a portion of a 3/8-inch diameter O-ring under the body flap. The rivet and O-ring have not yet been identified as flight hardware.

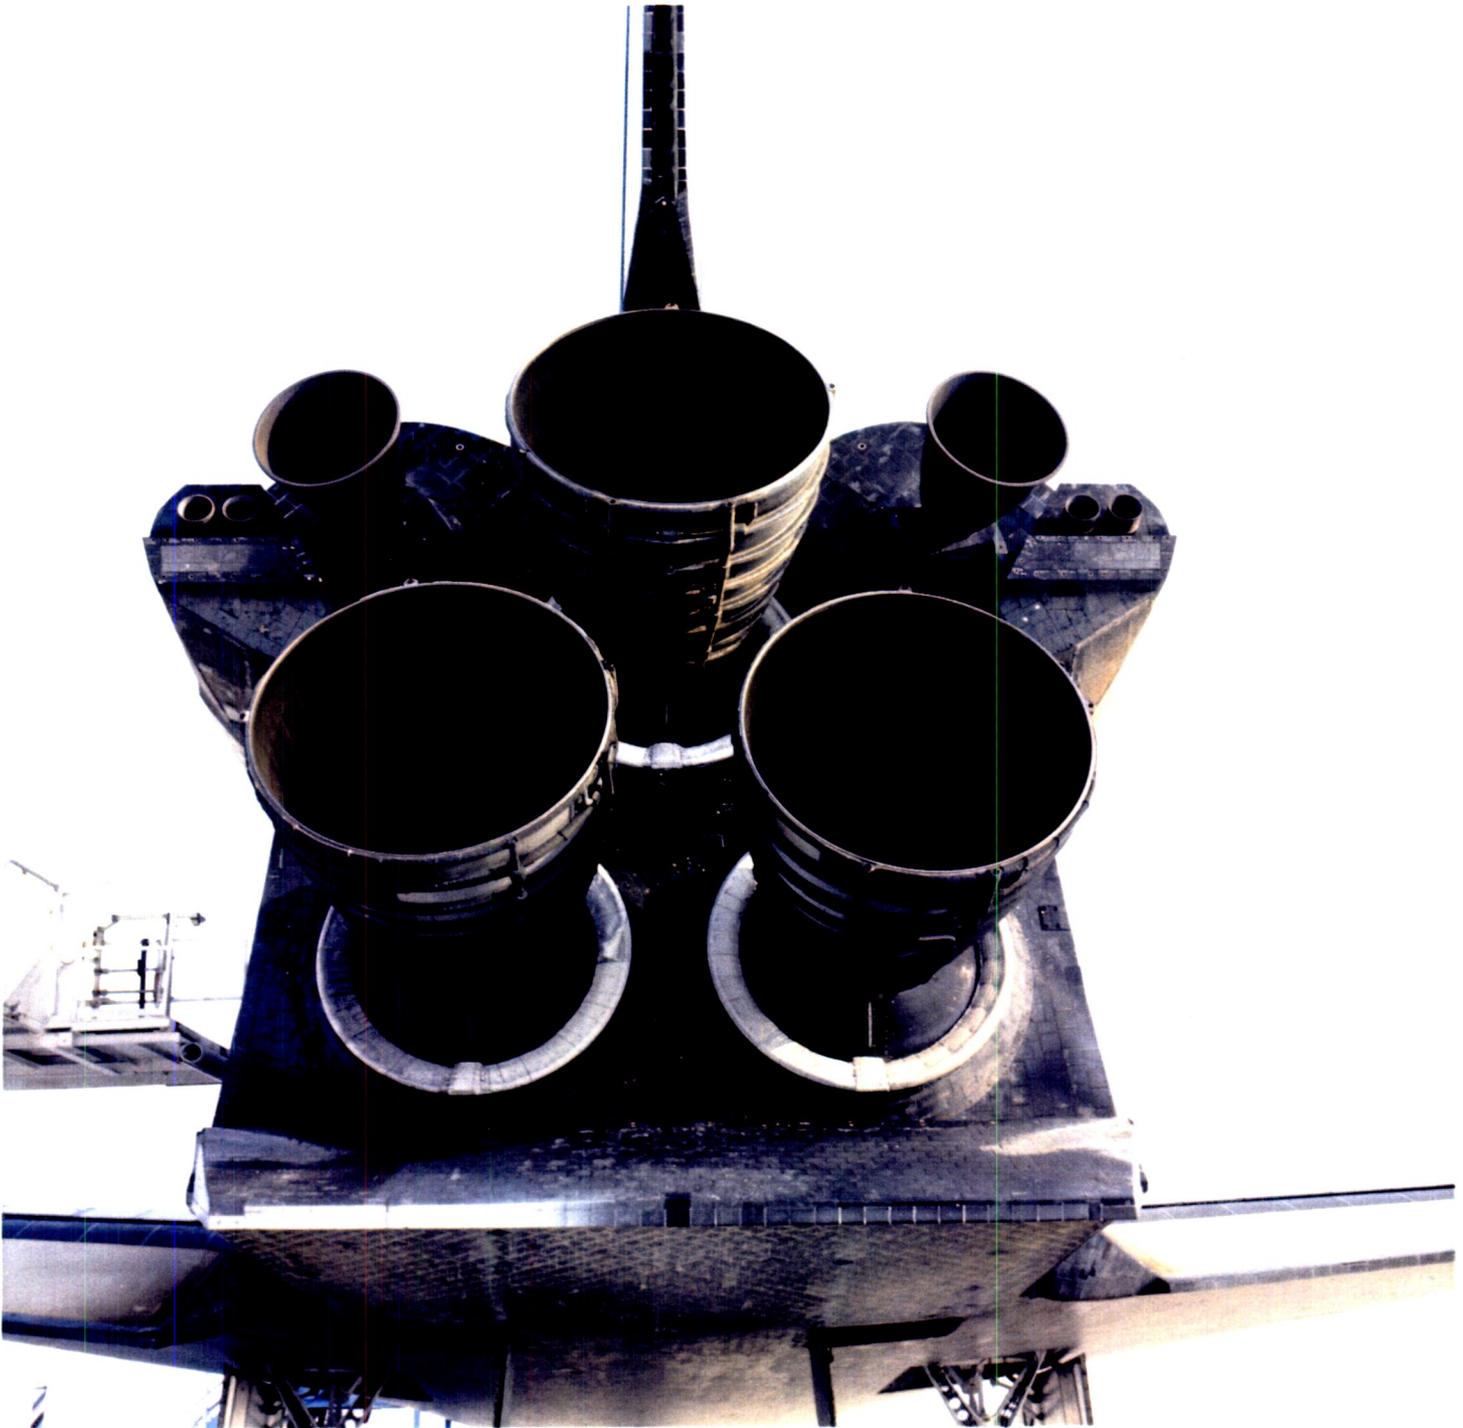
Photo 27 : Base Heat Shield

Tile damage on the base heat shield was slightly more than usual. The Dome Mounted Heat Shield (DMHS) closeout blankets were intact and generally in good condition with the exception of one torn panel at the 3 o'clock position on SSME #2.

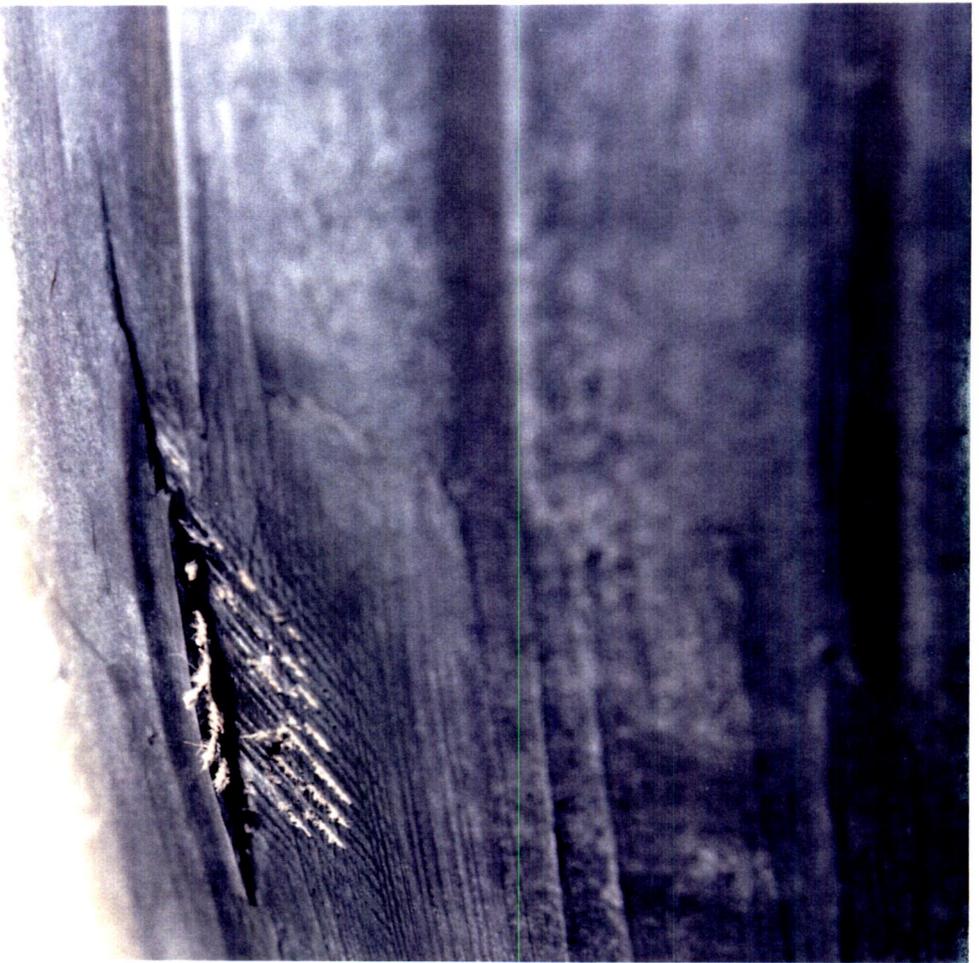
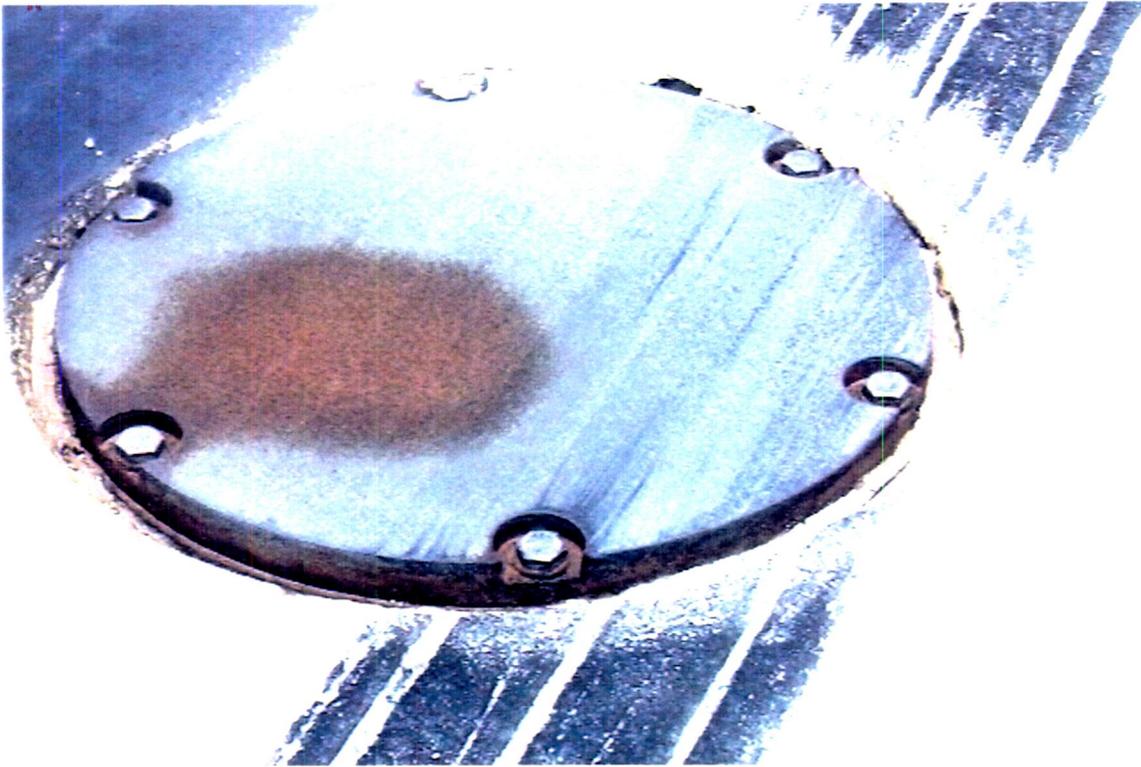
Photo 28 : Nose Gear Tire Damage

Main landing gear tires and brakes were in good condition for a landing on the KSC concrete runway. However, four pieces of rubber from the nose landing gear tire were recovered at the 5500 foot marker. The tire was damaged by contact with centerline light cover #4-9 protruding 1/4-inch above the adjacent runway concrete. This particular cover, one of 298 on the runway centerline, is 3/4-inch steel, 12 inches in diameter, and secured with six 3/8-inch bolts recessed into U-shaped cutouts. Filler compound, placed between the cover and the runway concrete, has not been a debris problem. Recent inspections identified nineteen centerline light covers exceeding a 1/8-inch protrusion (program specification). Several plans to correct the problem prior to the STS-69 landing are currently being assessed.

The nose landing gear tire was damaged by contact with centerline light cover #4-9 protruding 1/4-inch above the adjacent runway concrete. Recent inspections identified nineteen centerline light covers exceeding a 1/8-inch protrusion (program specification).
